SERVICE BULLETIN

Classification:	Reference:	Date:	
BF91-010	NTB91-047	May 9, 1991

DOOR WINDOW NOISE

APPLIED VEHICLE(S): 1991 300ZX

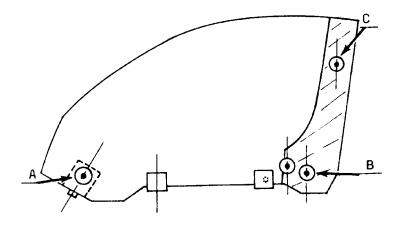
On some 1991 300ZX vehicles, a creaking/popping noise may be heard from the right or left door window. This noise occurs while the vehicle is being driven with the window partially or completely closed. To eliminate this noise, lubricate the window guide pins using the following service procedure.

- 1. Fully lower the incident door window.
- 2. Remove the door lower panel, upper seat belt assembly and door inner panel.
- 3. Remove the door window glass from the regulator.
- 4. Manually raise and lower the window glass in the guide rails to check that it moves without binding. If binding occurs, adjust the guide rails until it is eliminated (Refer to Technical Bulletin BF89-032/TS89-149, "300ZX Door Window Checks/Adjustments").
- 5. Remove the window glass from the door guide rails.
- 6. Carefully pry off the wheel caps from pins A, B and C using a sharp scribe, dental pick or equivalent. See illustration below.

7. Lubricate the inside hole in the wheel and around the end of the pins as indicated in the illustrations below.

NOTE: Use a multi-purpose grease (such as ball joint grease or grease with a higher viscosity). Do not use aerosol grease/lubricants (such as spray white lithium grease), since these greases do not provide sufficient durability.
