# SERVICE BULLETIN

Classification: BF89-023	Reference: TS89-125	Date: August 31, 1989
-----------------------------	------------------------	--------------------------

## DOOR WINDOW WAIST MOLDING FOLDING UNDER

**APPLIED VEHICLE(S):** 1990 300ZX (Z32)  
**APPLIED VIN(S):** JN1RZ24A( )LX006964  
JN1RZ26A( )LX001411

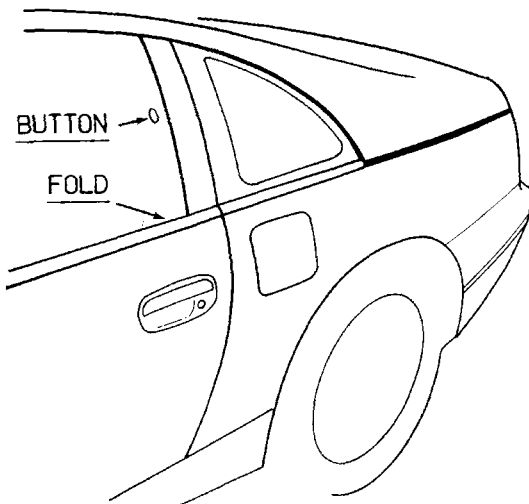
FIGURE 1

On some of the Applied Models, the door waist molding lip folds under at the window mounting button as the window goes down (Figure 1). This occurs when the clearance between the window and the top of the waist molding lip is too small (Figure 2). Starting with the Applied VINs, a bushing, has been slightly modified to allow the button to pass smoothly by the waist molding. This bushing is located between the button and the outside surface of the door glass.
