SERVICE BULLETIN

BF89-032

Z32 DOOR WINDOW CHECKS & ADJUSTMENTS

APPLIED VEHICLE(S): 1990 300ZX

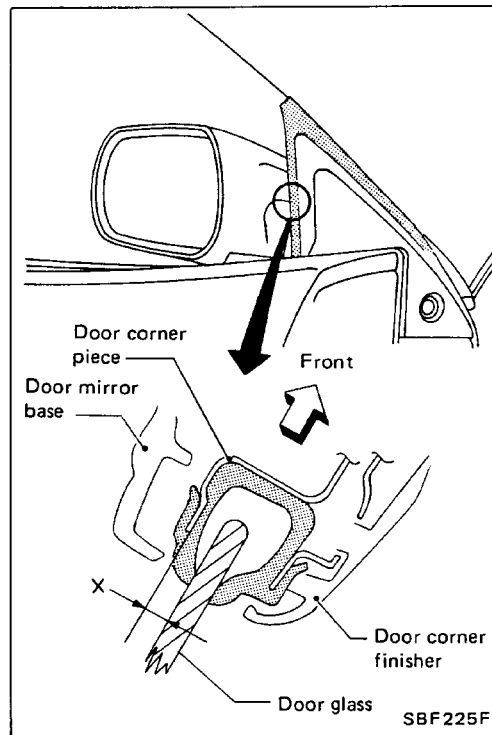
Service Procedure 3

1. Make sure that distance between door glass and door corner piece "X" is within specifications when door is opened.

Specified distance "X"

4.0 - 6.0 mm (0.157 - 0.236 in)

2. If not, adjust window front guide rail (see "SERVICE PROCEDURE 5" at the end of this bulletin.)
