SERVICE BULLETIN

BF89-034

DOOR WINDOW NOISE

APPLIED VEHICLE(S): 1990 300ZX (Z32)

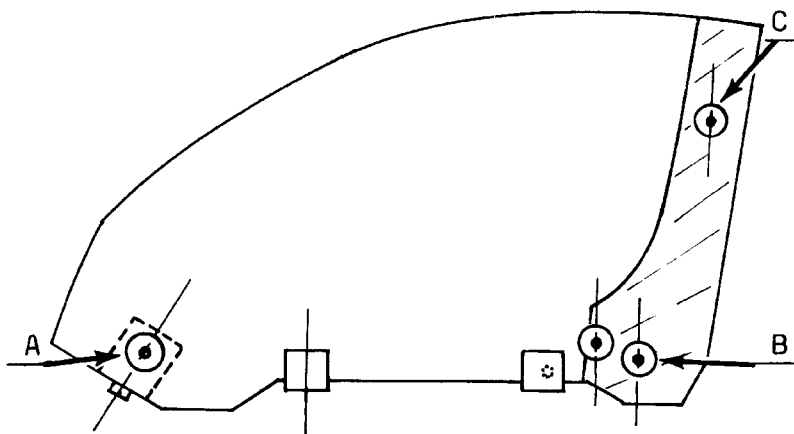
FIGURE 1

On some of the Applied Models, a creaking/popping noise may be heard from the right or left door window. These noises occur while the vehicle is being driven, with the window partially or completely closed. To eliminate this noise, lubricate the window guide pins, using the following service procedure.

1. Fully lower the incident door window.
2. Remove the door lower panel, upper seat belt assembly and door inner panel.
3. Remove the door window glass from the regulator.
4. Manually raise and lower the window glass in the guide rails to check that it moves without binding. If binding occurs, adjust the guide rails until it is eliminated (Refer to Technical Bulletin BF89-032/TS89-145, "300ZX Door Window Checks and Adjustments").
5. Remove the window glass from the door guide rails.
6. Carefully pry off the wheel caps from pins A, B, and C (Figure 1), using a sharp scribe, dental pick, or equivalent.
