SERVICE BULLETIN

BF89-032

Z32 DOOR WINDOW CHECKS & ADJUSTMENTS

APPLIED VEHICLE(S): 1990 300ZX

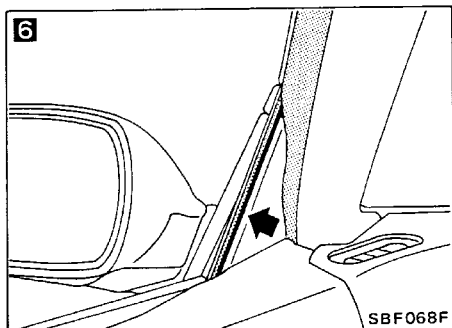
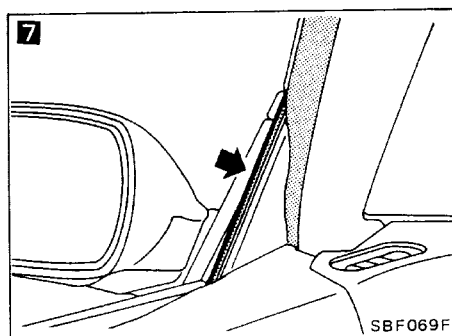
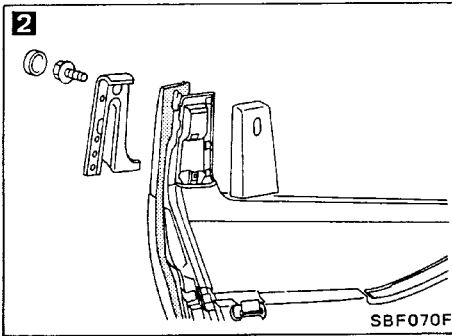
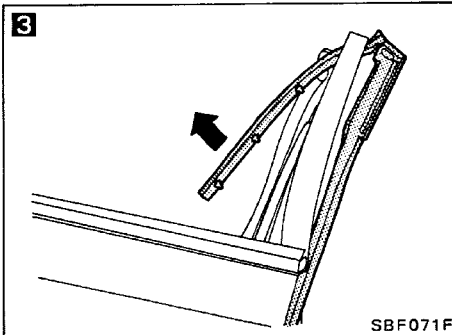
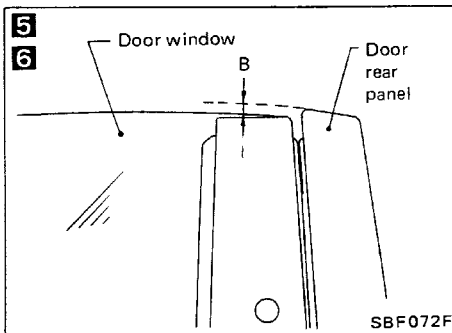
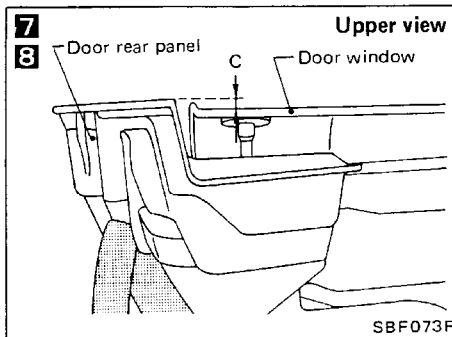
CHECK PROCEDURE 1

SYMPTOM: Noise comes from around door mirror when driving at high speed.

1. Remove door finisher and door corner finisher.
2. Loosen the 3 bolts fixing door mirror.

3. Tilt door mirror as much as possible in the direction shown below and tighten the 3 bolts.

4. Pull door weatherstrip as low as possible as shown below.
5. Install door corner finisher.
6. Make sure that door glass touches door weatherstrip properly.
